6 National Dam Inspection Program.
White Oak Pond Dam (NDI Number
PA-00147, DER Number 64-12),
Delaware River Basin, Wayne
County, Pennsylvania. Phase I
Inspection Report. ~~REDACTED~~

PHASE I REPORT
NATIONAL DAM INSPECTION PROGRAM

Name of Dam: WHITE OAK POND, NDI NO. PA-00147
State & State No.: PENNSYLVANIA, 64-12
County: WAYNE
Stream: TRIBUTARY OF WEST BRANCH LACKAWAXEN RIVER
Date of Inspection: October 24, 1979

DATE: January 25, 1980

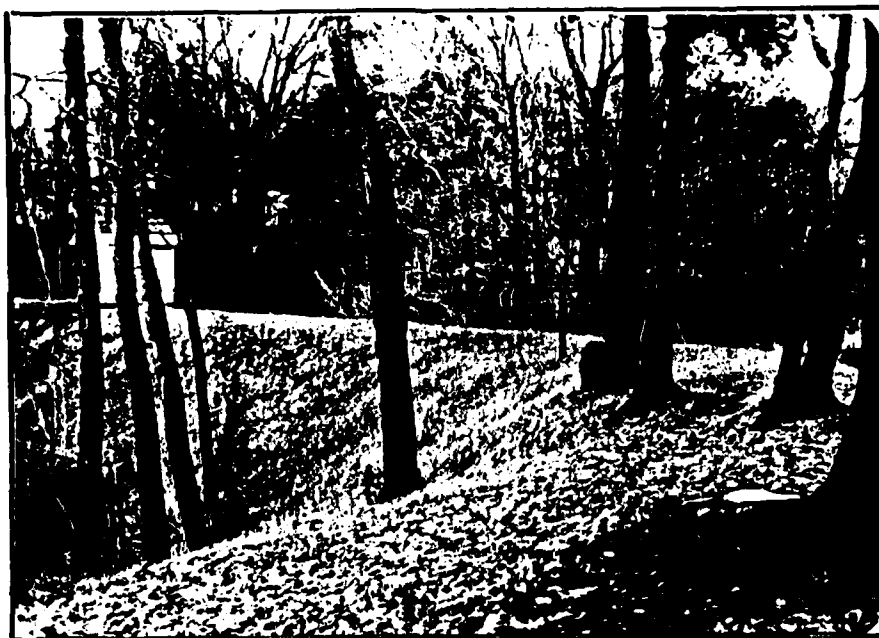
RIGHT END OF EMBANKMENT - NO. 2

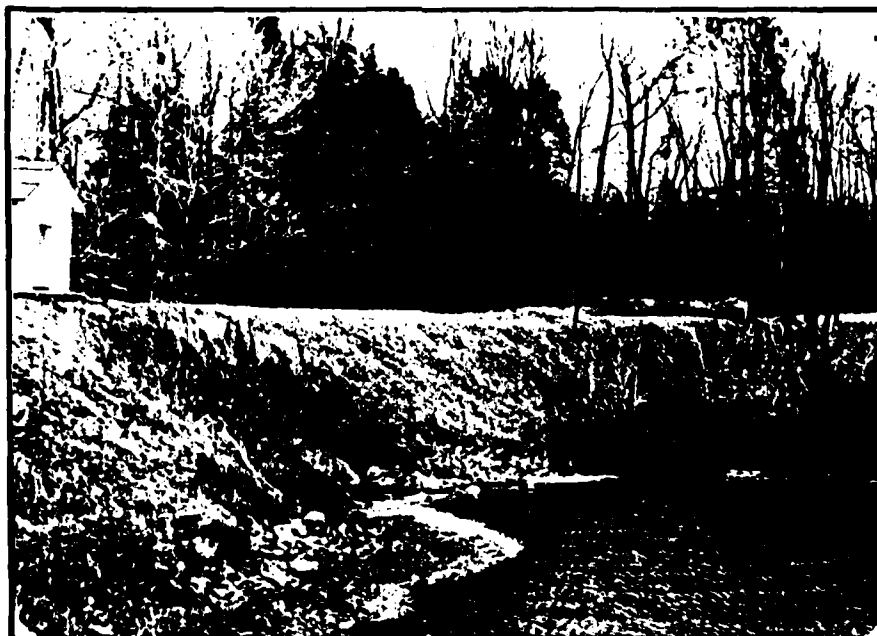
The dam was constructed along a horizontal curve. The alignment appeared to be good along this curve. The upstream slope is rather steep, but no slope failures were detected. Riprap is present near the entrance to the underwater intake to the wetwell. Some brush was on the upstream slope. This growth should be controlled by regular cutting. Trees growing near the left abutment are not considered a danger to the structure due to the width of the dam breast at this point and the relatively flat slopes.

UPSTREAM SLOPE OF EMBANKMENT - NO. 3

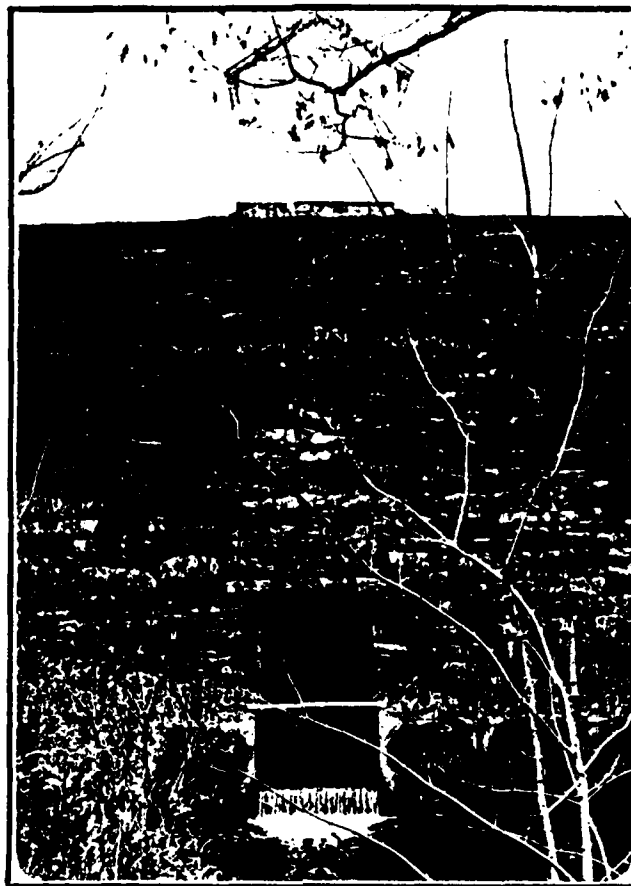
The wetwell is constructed of loose stone walls and the only apparent concrete was for support of the stoplog slot. The well and the stoplogs appear to be in good condition. The upstream conduit is under water and was not inspected. The downstream conduit was in good condition.

DOWNSTREAM CONDUIT OUTLET - NO. 8

4. That the downstream section of the outlet conduit be inspected on an annual basis for possible deterioration of concrete floor.
5. That a formal surveillance and downstream warning system be developed to be used during periods of heavy or prolonged precipitation.
6. That a program be developed for regular inspection and maintenance.

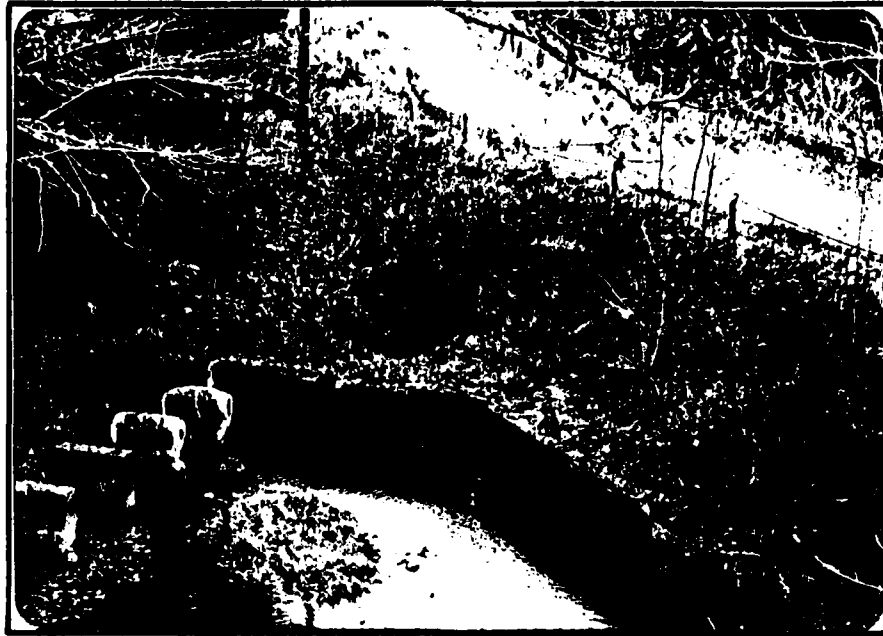
DOWNSTREAM CHANNEL WITH CATCHBASIN - NO. 10
